LEVEL 2 REPLACEMENT RESERVE REPORT FY 2021 HAMPSHIRE GREENS HOA

REPLACEMENT RESERVE REPORT

HAMPSHIRE GREENS HOA

SILVER SPRING, MARYLAND

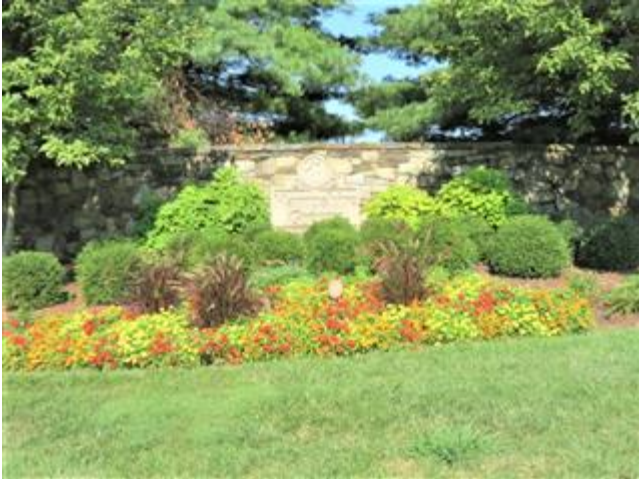
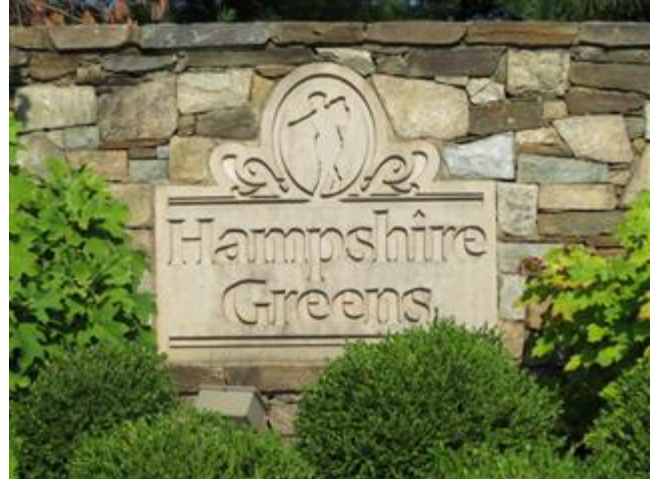
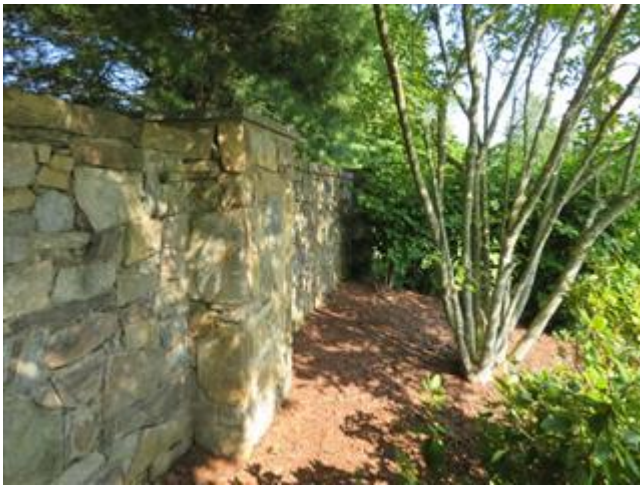
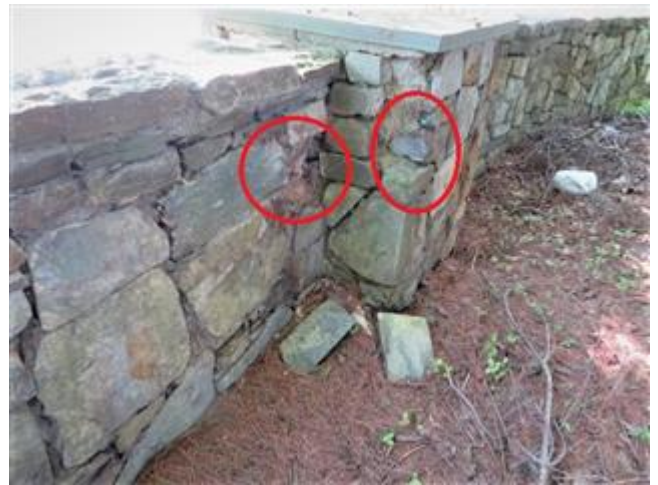
All of the stone wall structures have significant vegetation going on the stone work. we recommend that the vegetation be trimmed a minimum of 12" away from the stonework to provide access for annual inspections and routine repairs, including tuckpointing. The clear space also allows any moisture that has accumulate to evaporate.

- The entrance at New Hampshire Ave. and Bay Hill Lane has two stone veneer structures, with the unit on the right side (entrance side) of the intersection also containing a carved stone signage panel. The entrance monument unit is in fair condition, with several displaced stones on the rear elevation.

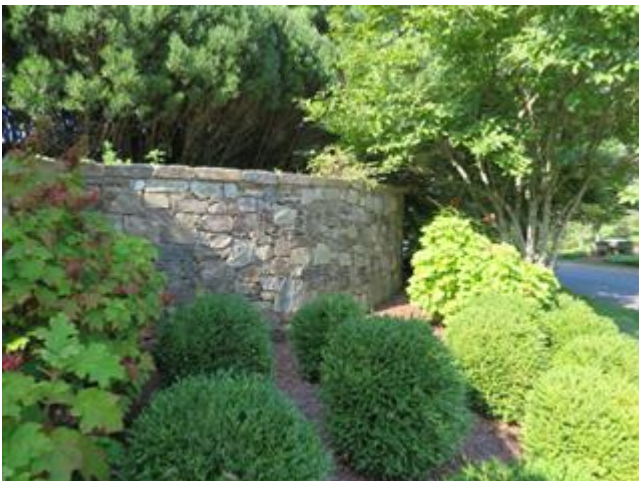
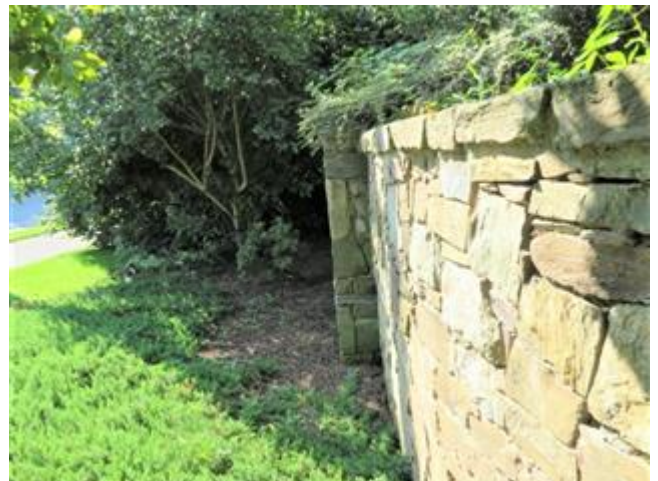
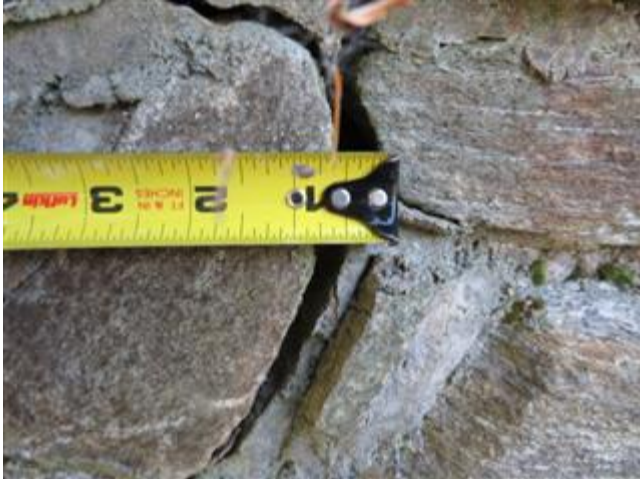
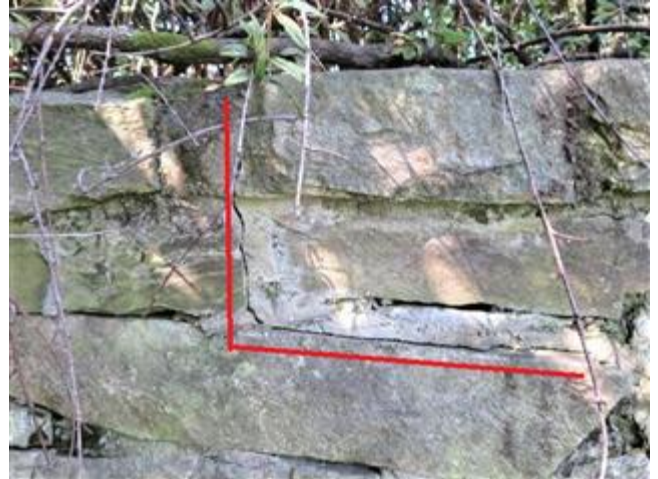
- The retaining wall unit on the left side (exit side) of the intersection is in poor condition. We observed an approximately 50% of the retaining walls has sufficient leaning. Leaning occurs when the pressure of the material being held in place by the retaining wall is sufficient to cause the wall to shift away from the vertical. Once a retaining wall starts to lean, it is at risk of failing and must be replaced. The replacement costs presented in this report are for preliminary budgeting purposes only, based upon limited information and do not include any reserve or contingency for inflation or unforeseeable construction requirements. Accurate cost figures for the required remedial work cannot be properly developed until design work (preparation of specifications, proposals and drawings if required) has been completed and approved by the Association. We will revise our replacement cost projections, once the Association provides copies of the written proposals detailing the scope of the work to be conducted.

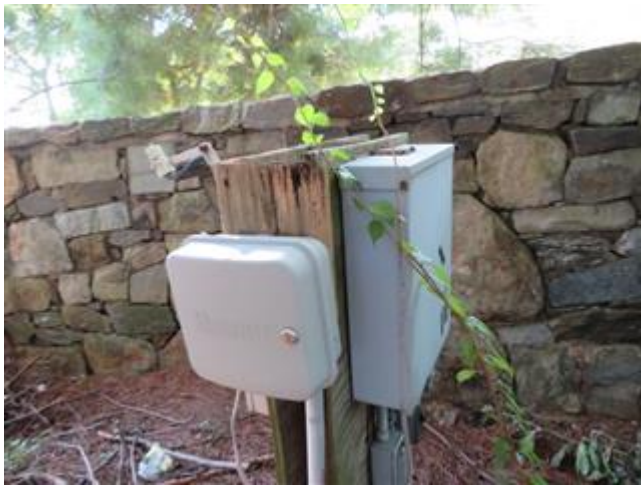
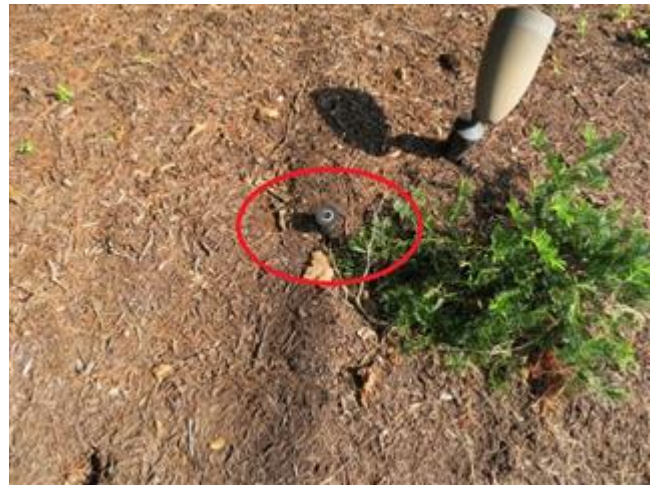
- The Association operates an irrigation system that serves the entrance monument / retaining walls at New Hampshire Ave. and Bay Hill Lane. The system includes sprinkler heads, electronic controls, and a network of underground lines. We consider the replacement of individual heads, valves, and sections of the underground piping to be normal maintenance expenses and have excluded them from the Reserve Analysis.

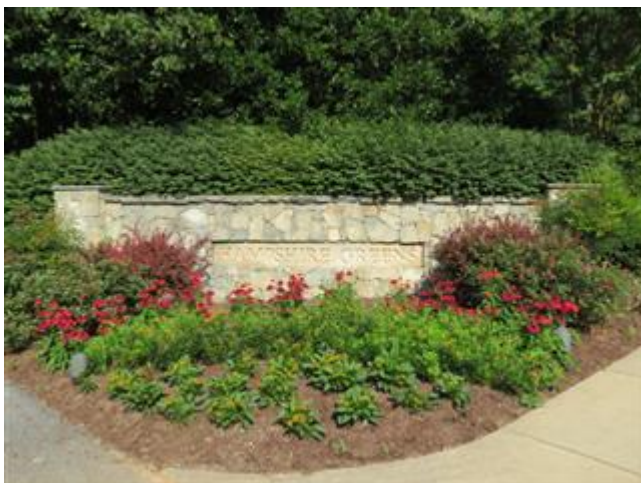
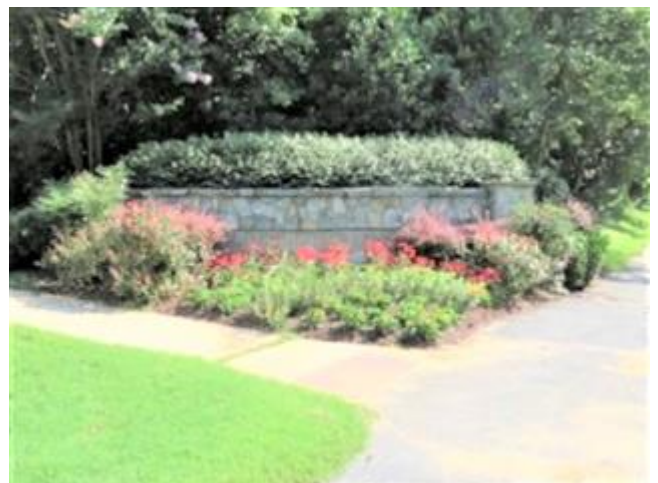
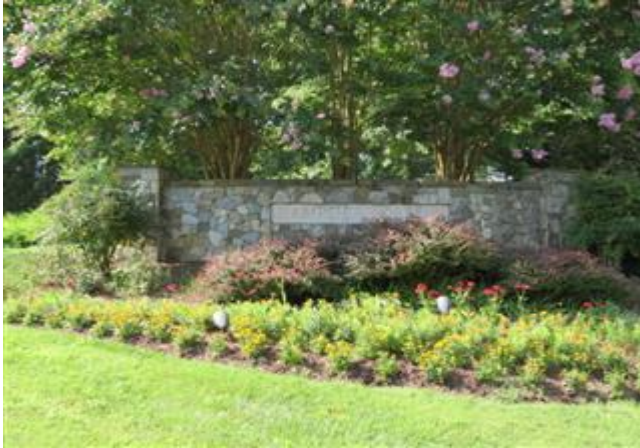
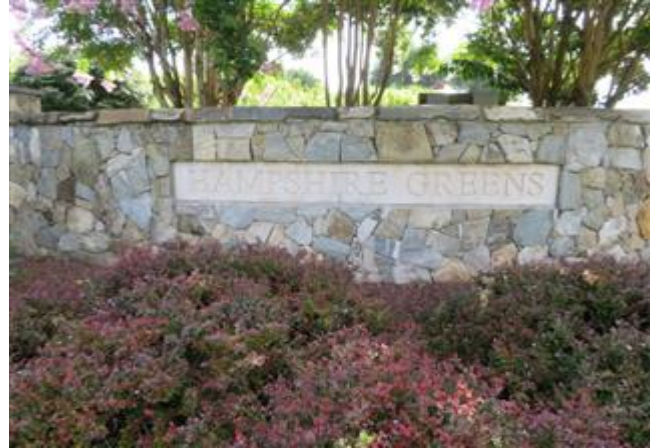
- The community maintains two stone veneer structures at each of the entrances to the community at Firestone Drive & Norbeck Road and Harbour Town Dr & Ednor Road. The monuments are constructed of columns and walls clad with stone veneer with carved stone signage attached to the roadside face of the monuments. The entrance monuments are in fair condition.

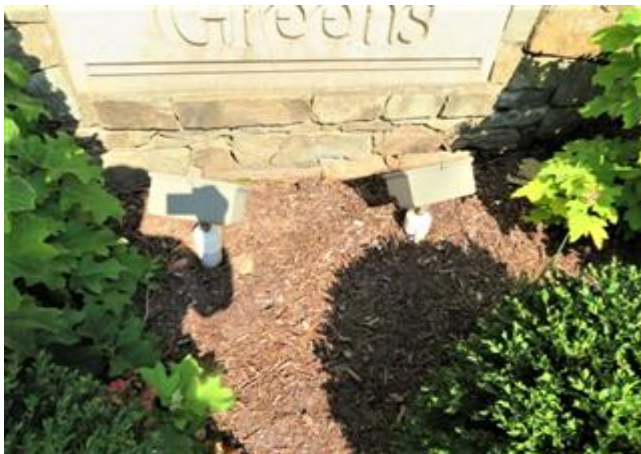
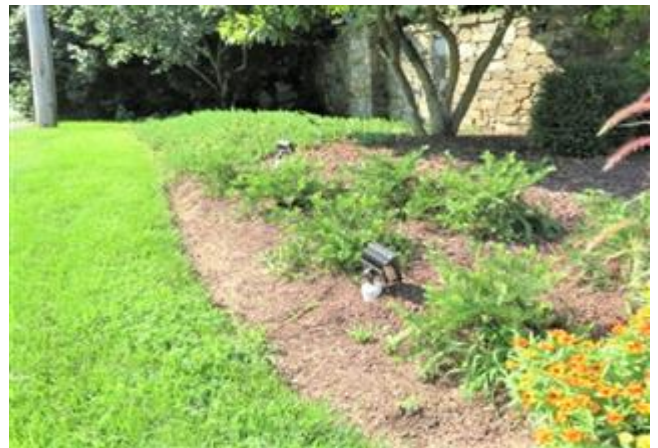
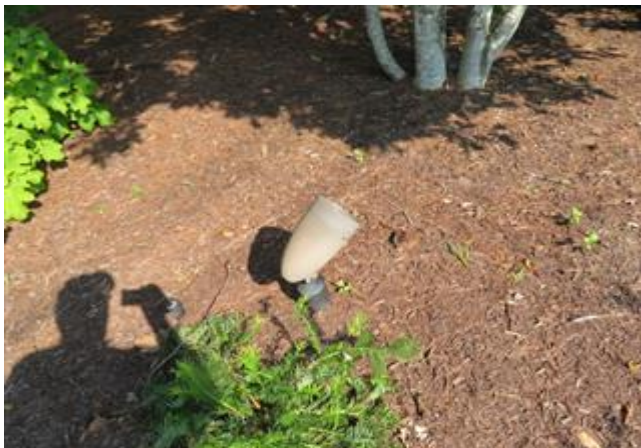
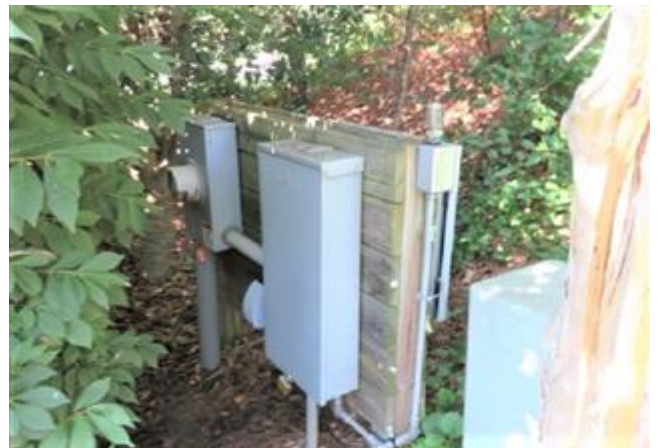
Entrance Monument Lighting. The community's monument illumination is provided by ground mounted spot flood lights. The lighting system was not on at the time of our site visit and we understand that the lighting system is in operating condition. We have provided funding for the normal replacement of the lighting fixtures, electric service meter, distribution panel and assumed that the accessories (lens, bulbs, etc.) will be replaced as part of the normal operating budget. Our estimates are based on standard life cycles and on replacement with like items.

The Association maintains has a number of electrical distribution panels that control electric power to the entrance monument lights. These panels separate the electrical power feed into separate circuits while providing protective circuit breakers for each circuit. These panels date to the original construction of the community and have a rated service life of 50 years or more. The overall condition of the distribution panels is good. As the distribution panel's age, obtaining replacement parts can be expected to become more difficult. When parts no longer are available, the Association will have to replace some of the existing panels. Replacement will have to be performed on an incremental basis, panel by panel. Therefore, we have included funding in the Reserve Analysis for distribution panel replacement on an incremental basis.

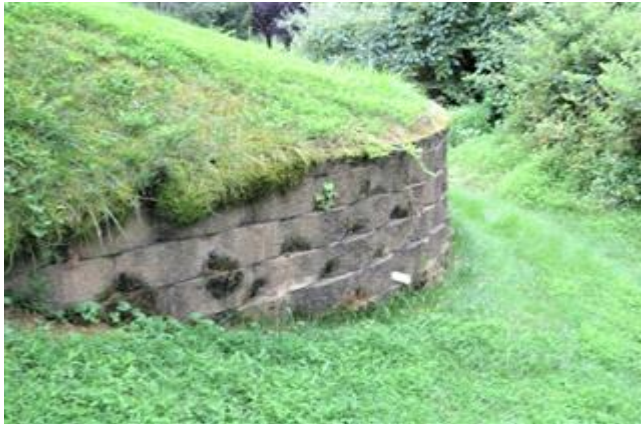
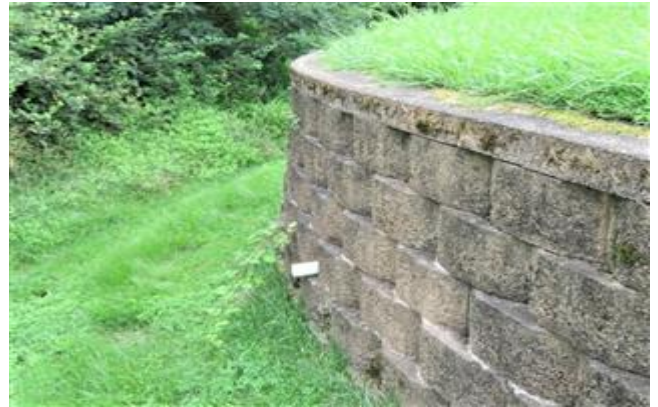
Segmental Block Retaining Wall. The community maintains an inventory of 210 square feet of segmental block retaining wall. Segmental block retaining walls can have an extended useful life, and if stable, are likely to only require localized resetting of displaced blocks, typically near the top of the wall. This study assumes that resetting will be performed incrementally as needed. The overall condition of these walls is fair.

The industry considers this type of retaining wall to be maintenance-free for 40 years and have an estimated service life of 80-100 years. If this conclusion is accepted, there is no need to reserve for this very significant component. However, if major work must be performed on this wall at some point in time because of settlement, erosion, latent construction defects, etc., the cost will be very high. Therefore, we have included funding for resetting / replacement of 30% of this wall at 40 years, which permits the association to accumulate slowly for this possibility.

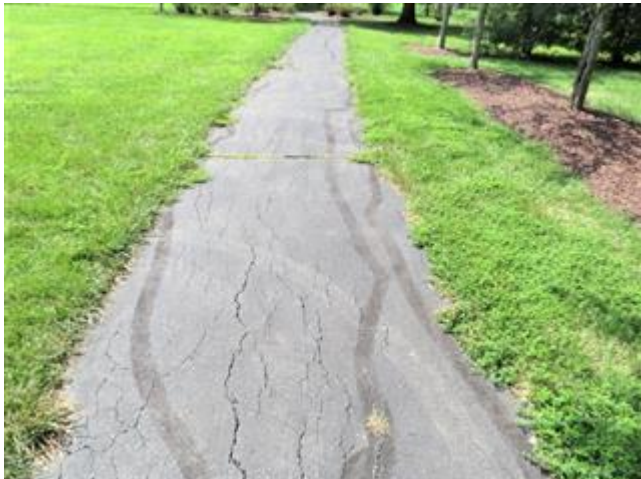
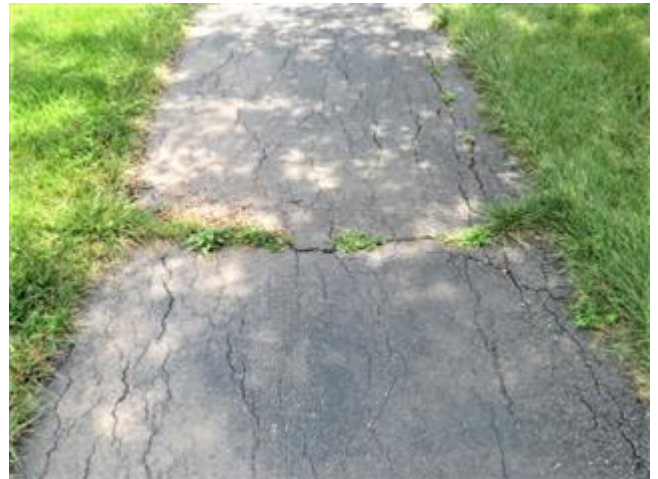
- **Cracks.** There are multiple locations where open cracks are allowing water to penetrate to the asphalt base and the bearing soils beneath the pavement. This water will erode the base accelerating the deterioration of the asphalt pavement. If the cracks have allowed the deterioration of the base materials and the bearing soil, the damaged areas should be removed and replaced. All other cracks should be cleaned and filled.

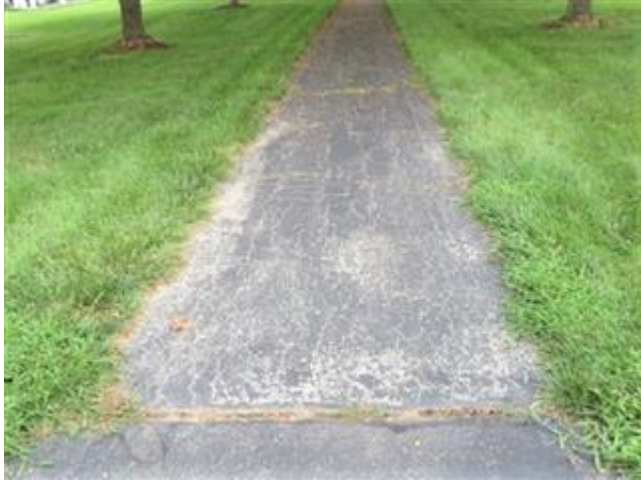
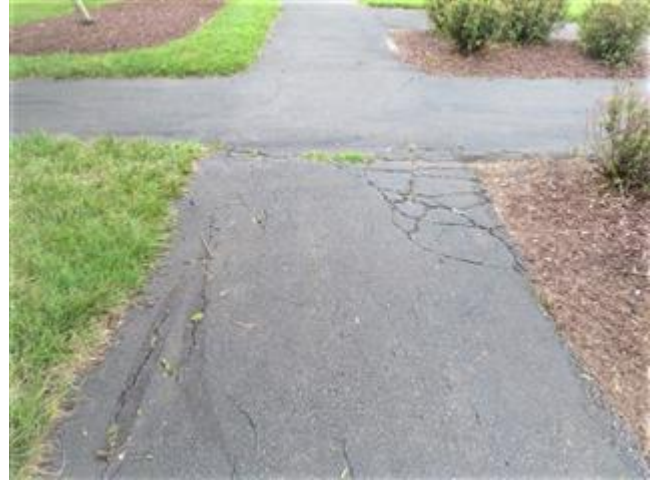
- **Raveling and Aging.** Asphalt raveling occurs when small crack formations expand and allow water and debris to permeate the surface of the pavement. As the cracks continue to expand over time, small particles of aggregate break apart and eventually compromise the foundation of the pavement. Over time, the broken pieces of aggregate become bigger and bigger until potholes start to form. The pavement loses its smooth surface and begins to appear very open and rough. The severity is rated by the degree of aggregate and binder loss.

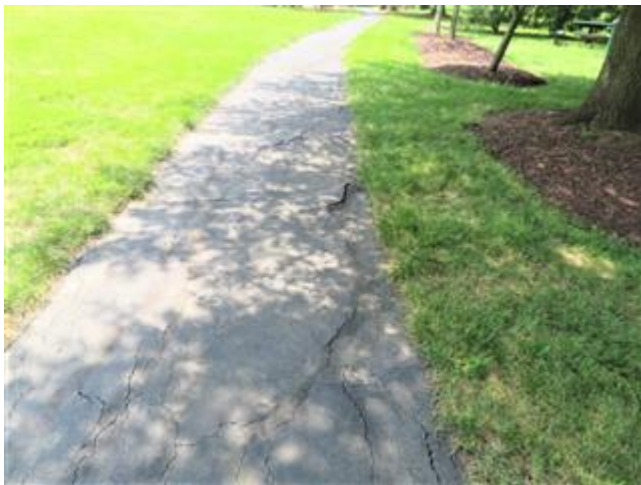
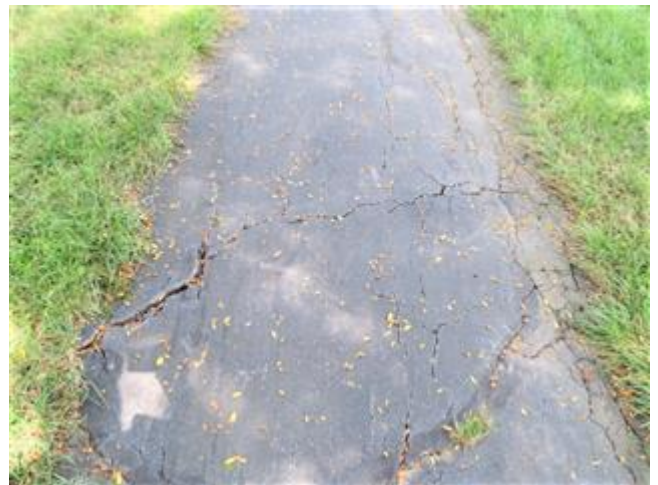
- **Tree Root Damage.** There are locations where roots from trees planted near the asphalt surface have pushed up through the asphalt, causing cracks and heaving. Repair of these areas will require removal of the asphalt and the tree roots.

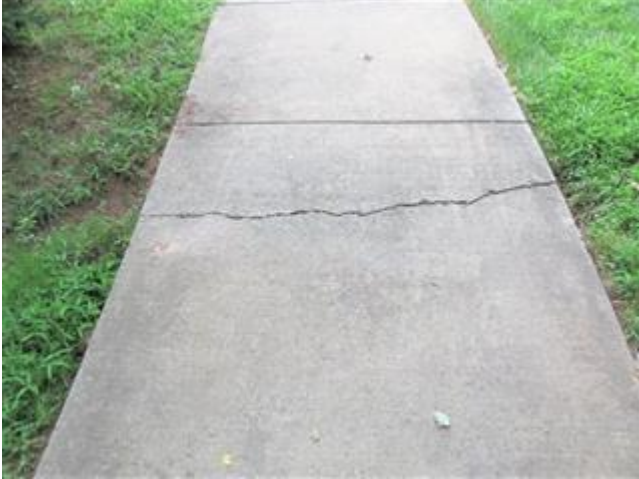
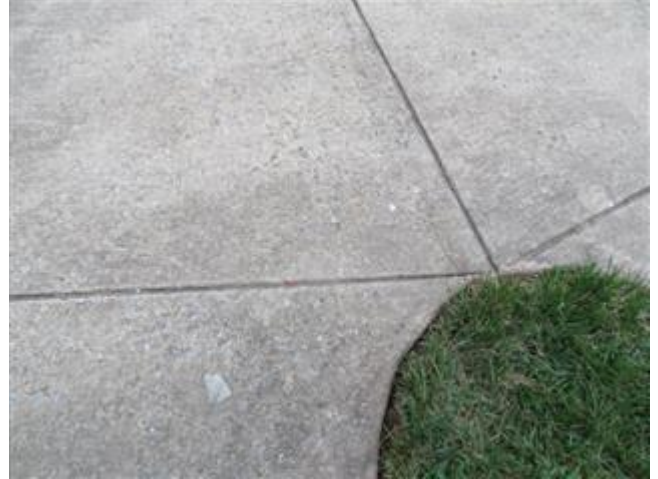
Concrete Work. The concrete work includes the community sidewalks at the gazebo and tennis courts areas along Bay Hill Lane. The overall condition of the concrete flatwork is fair with the following defects noted:

- Cracking. There are several sections of the concrete flatwork that have cracked.
- Scaling and flaking are the loss of the surface mortar in concrete, typically caused by water freezing within the concrete. Once started, scaling and flaking can be expected to continue to grow as a result of exposure of the concrete to freeze-thaw cycles.

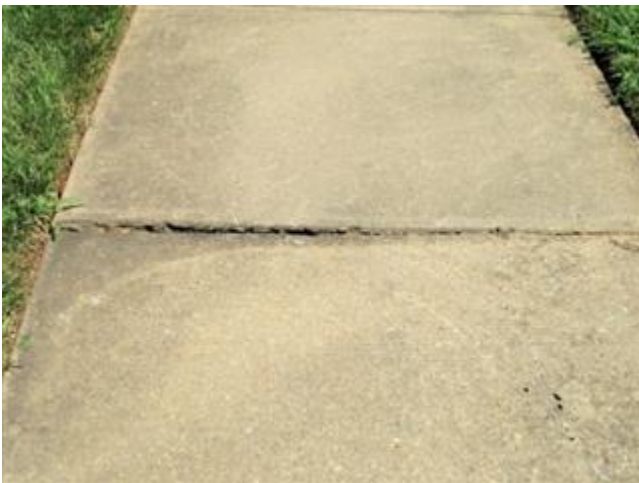
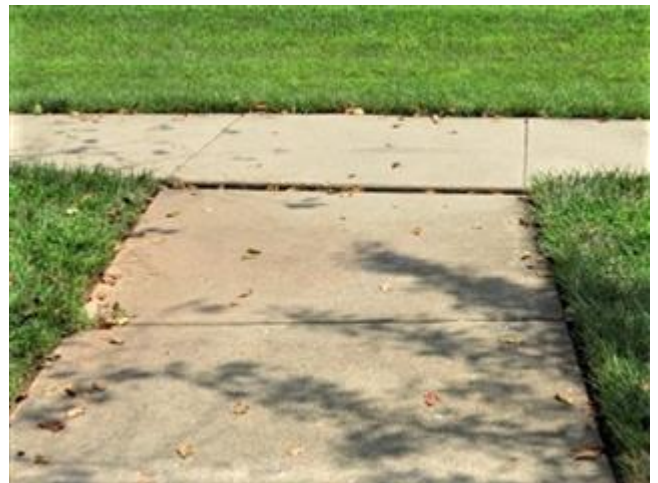
- Heaving/Settlement. Sections of the concrete flatwork have heaved or settled relative to their adjacent sections, creating trip hazards. Americans with Disabilities Act (ADA) defines a trip hazard as any vertical change of ¼" or more at a joint or crack in a walkway surface.

- Trip hazard, ½ inch height difference.
- Severe cracking.
- Severe spalling and scale.

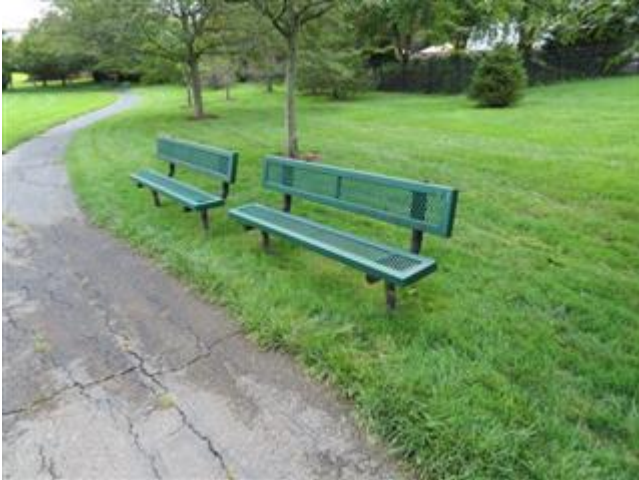
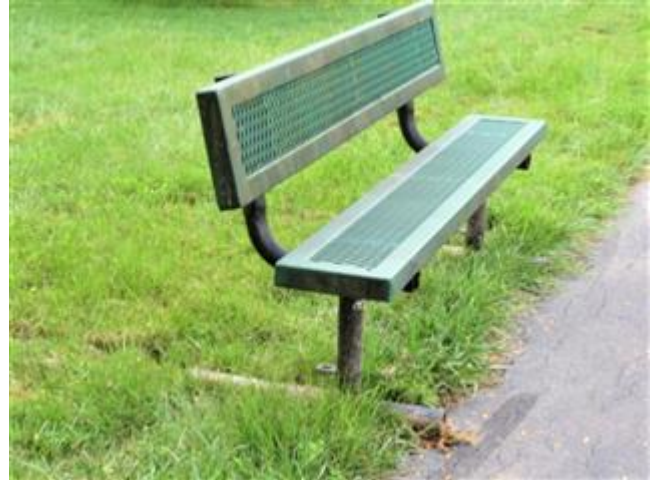
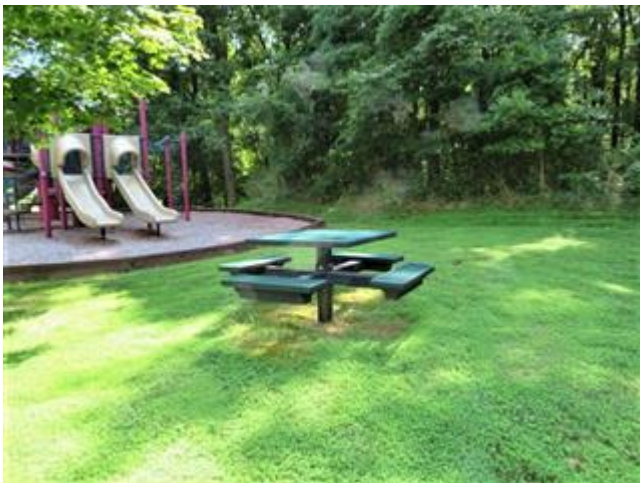
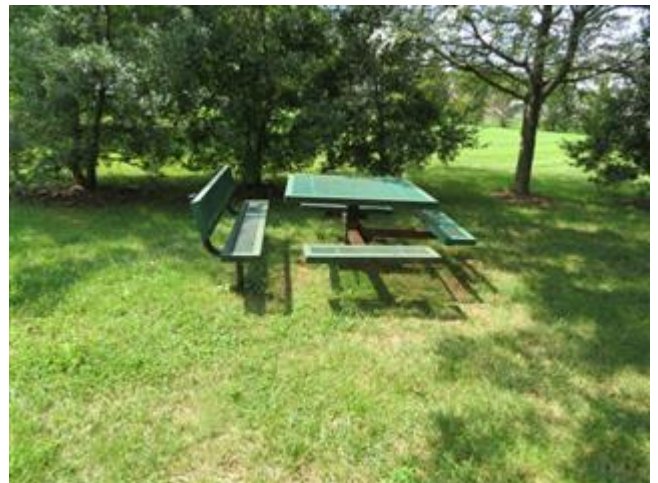
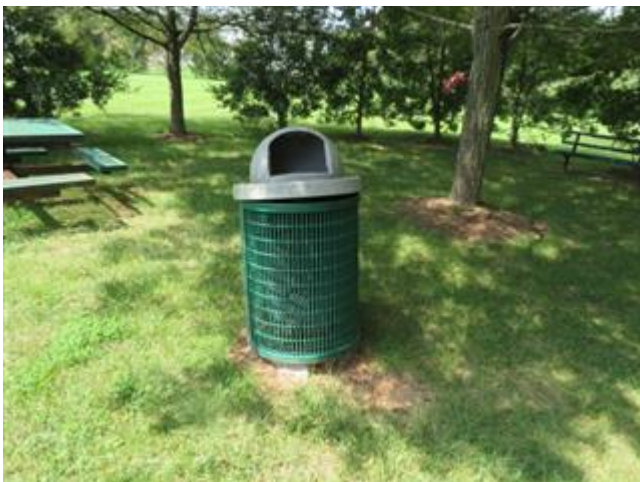
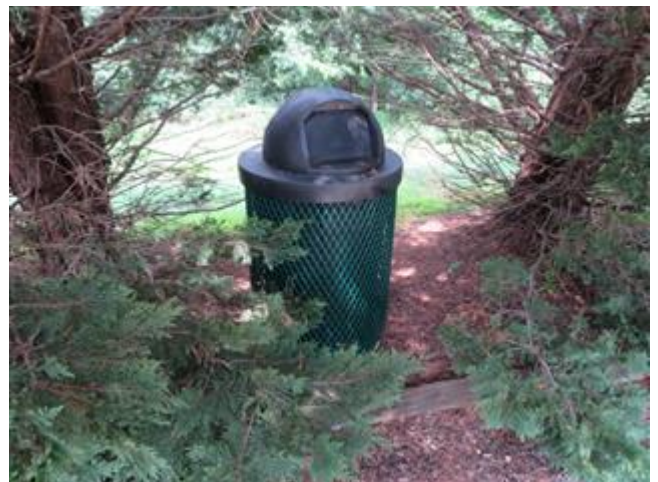
Sitting Areas. The Association maintains sitting and picnic areas along the open space asphalt paths and at the two tot lot areas. The areas include metal benches, metal picnic tables and trash containers. The benches, picnic tables and trash containers are in generally fair condition. We have provided an estimate of the approximate replacement cost based on our experience with other communities of similar size and on our inspection of the visible components while on site. We assumed a life expectancy of 20 years for the benches and picnic tables and 10 years for the trash containers.

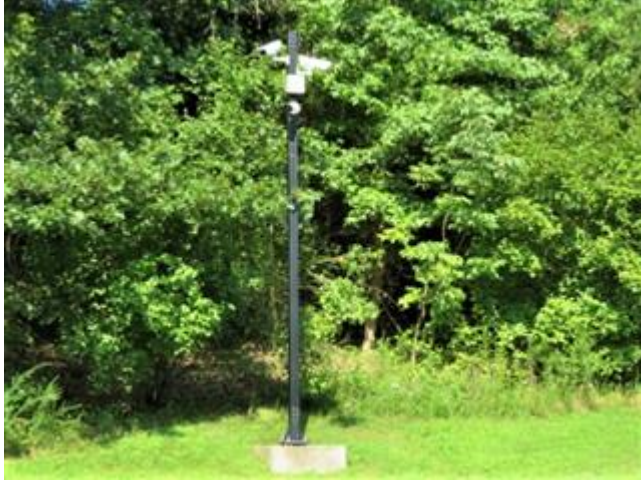
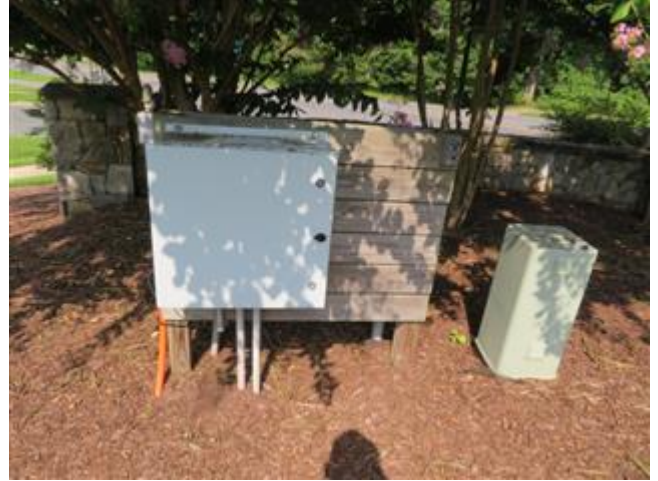
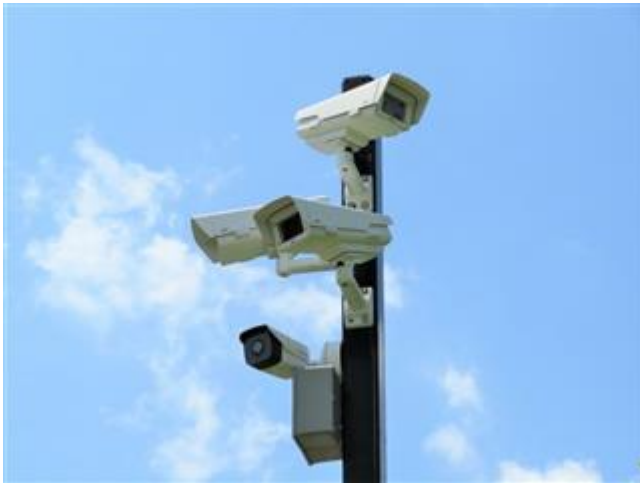
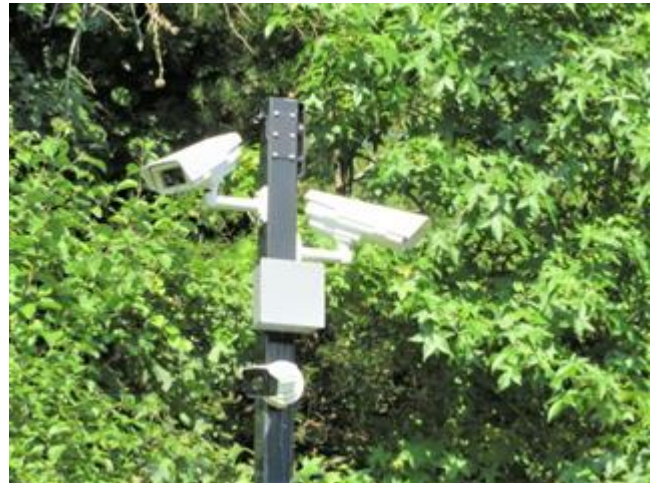
Security Camera System. The Association is responsible for the maintenance and operation of the street security camera systems. Cameras are located at the intersections of Bay Hill Lane and Harbour Town Drive; on Firestone Drive, approximately 200 feet north of the intersection of Norbeck Road and on Harbour Town Drive, approximately 125 feet southwest of the intersection of Ednor Road. It is our understanding that the original security camera system was installed in 2014 with License Plate Capture (LPR) cameras and video encoders added in 2015. The Association is currently

replacing the off-site recording system with on-site recorders and encoders, mounted in the NEMP enclosures installed adjacent to the electric service and meter panels.

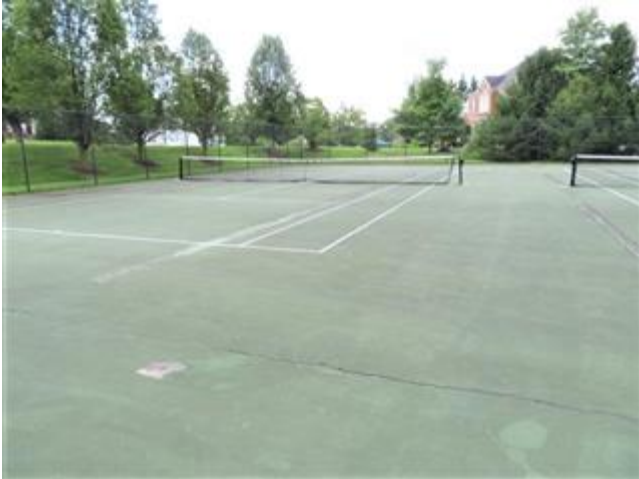
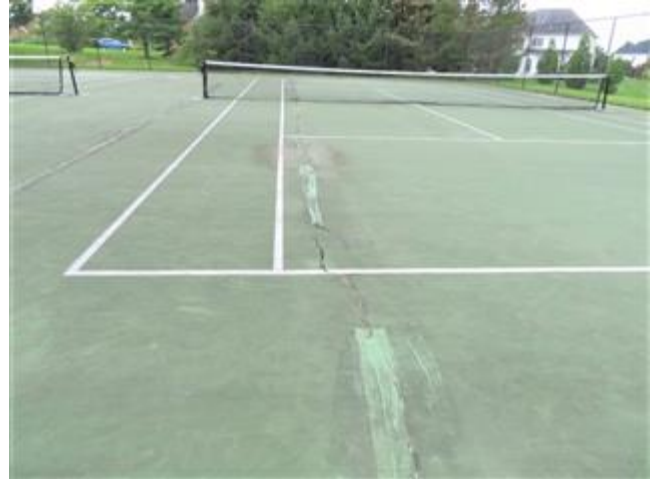
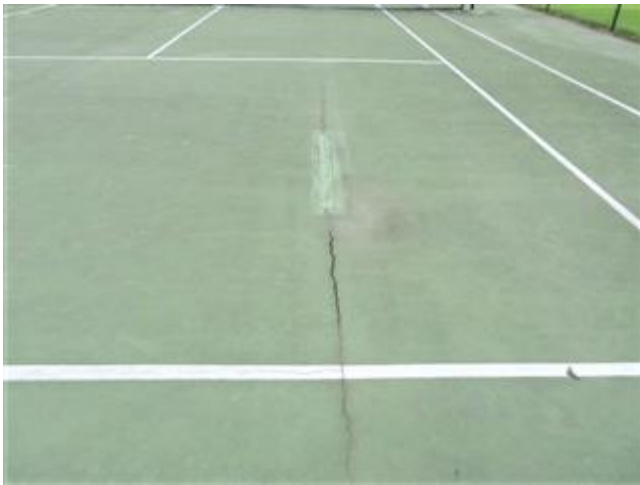
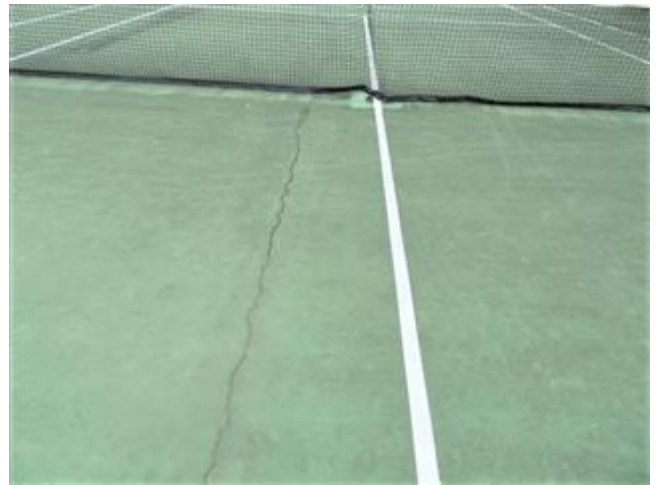
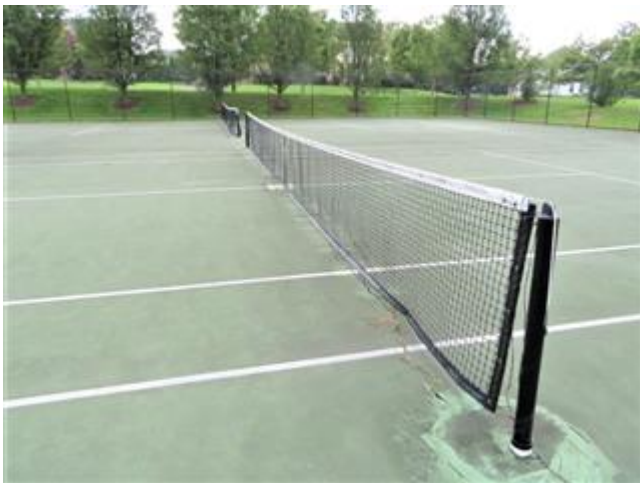
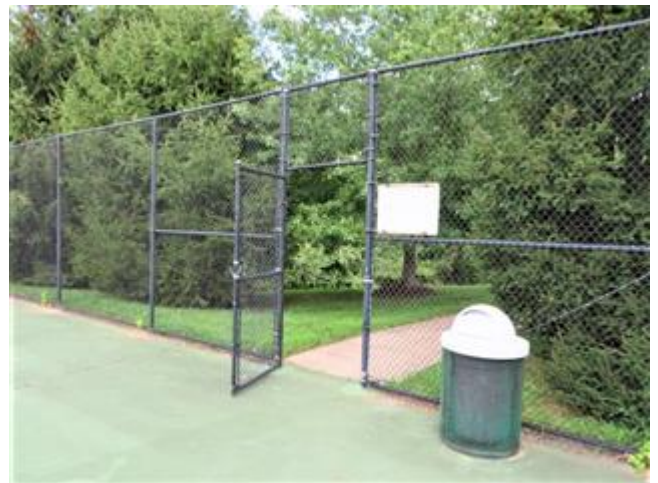
Tennis Courts. The community maintains a single tennis court multiple tennis courts. The overall condition of these courts is marginal, with open cracks and indications of previous repairs throughout both courts. The fencing is in generally fair to marginal condition.

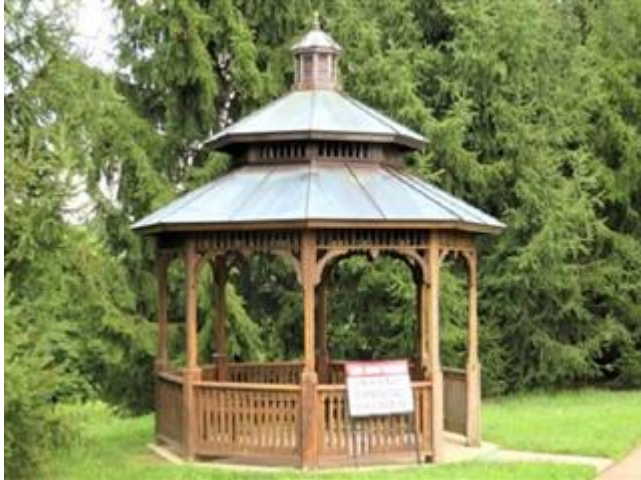
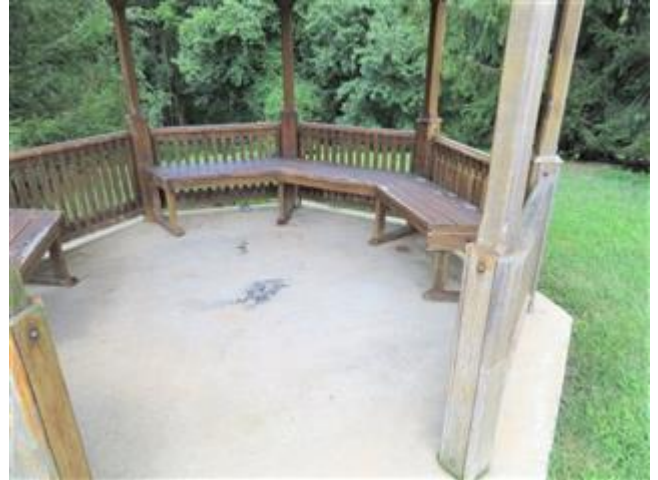
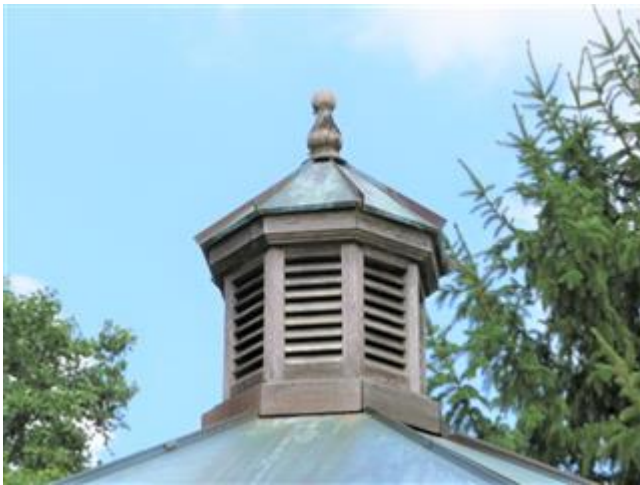
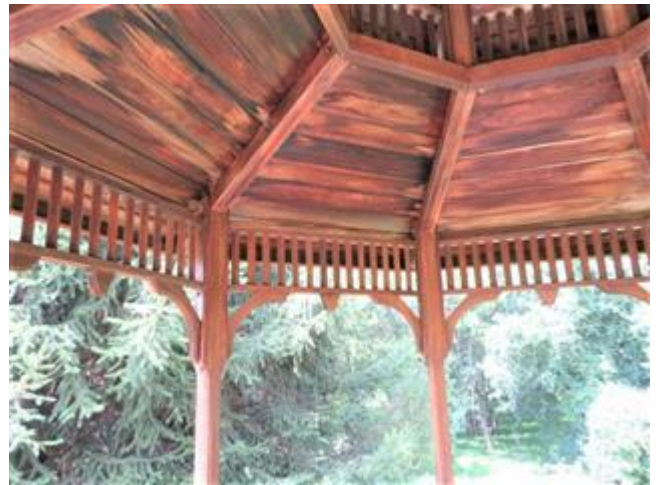
Gazebo. The Association maintains a gazebo of wood construction. The gazebo has a concrete floor, stained wood support and railing system, stained ceiling, 5 benches and standing seam metal roofing. The gazebo is in generally fair condition; however the wood components are weathered and one section of the built in seating is missing. The rate of deterioration of the wood components of the gazebo will vary with the level of maintenance performed on those components as well as the exposure of the gazebos to the elements. Gazebos of this type can be expected to have a service life of 40 years when properly maintained.

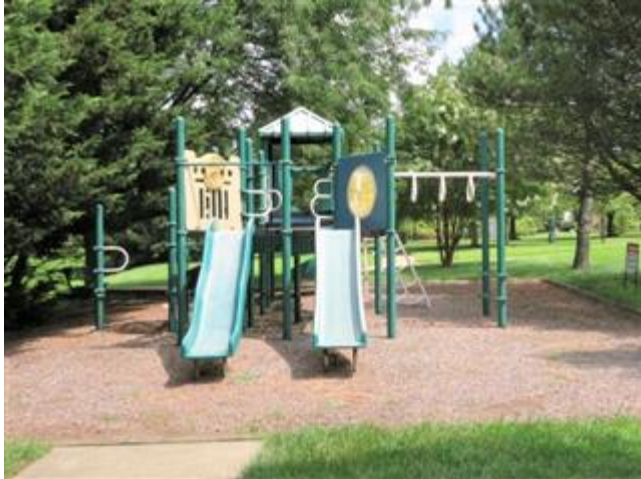
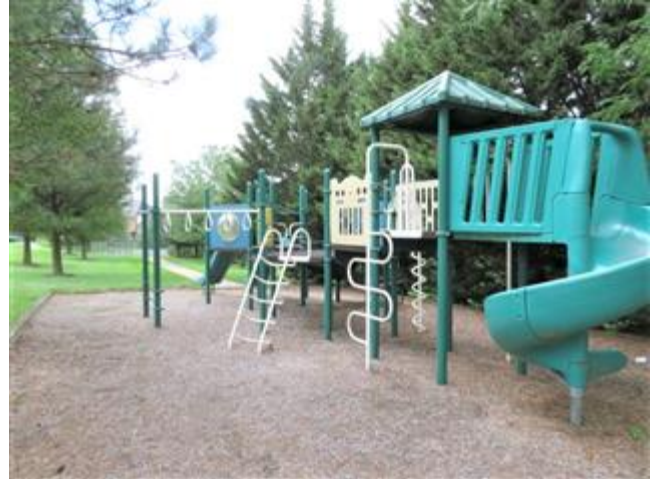
- Tot Lot A. The Association reported plans to remove the tot lot in 2021. Our research includes contact with Miracle Recreation (manufacture of tot lot equipment) who forwarded us to Michael Slifer of Metro Recreation, their local representative. The estimate of removal cost used in this report is based on our conversation with Mr. Slifer. We have included allowance for the installation of 250 sf of concrete sidewalk and re-landscaping of the area. Based on conversation with Ms. Wildman, the bench and trash container located in this area will remain.

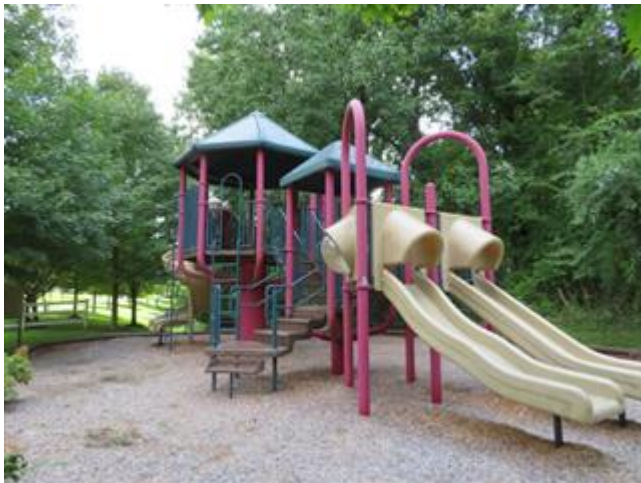
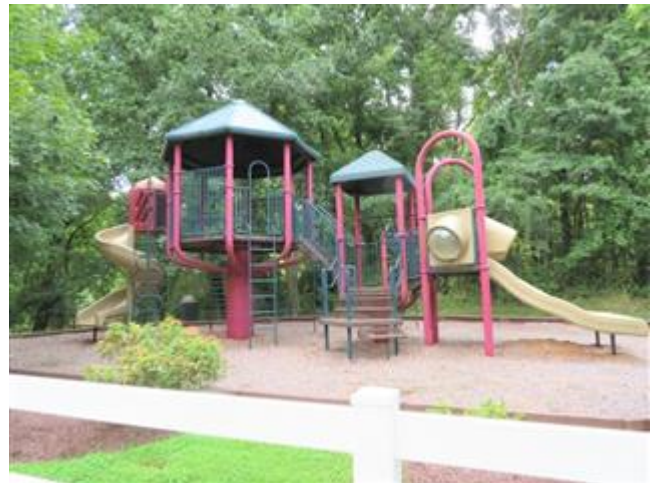
- Tot Lot B. The tot lot includes a large play structures, synthetic borders, and a wood mulch safety surface. The tot lot is in generally fair condition with minor wear and a few loose connections. The wood chip surface is displaced or missing or does not appear to be adequate. The replacement cost used in this study are based on discussions with Mr. Slifer, and includes removal and installation of the play equipment based on the cost for the current equivalent equipment, expansion of the use zone (current use zones around the equipment do not comply with current safety standards), new borders and new wood safety mulch. Special consideration should be given to providing accessible surfaces in a play area that meets the ASTM Standard Specification for Determination of Accessibility of Surface Systems Under and Around Playground Equipment, ASTM F1951. Equipment selection and location along with the type of protective surfacing are key components to ensuring the opportunity for children with disabilities to play on the playground.
